## Cosmix Valve Replaces Zirconia; Quadruples Service Life

Dino L. Tsapatsaris, Fujikin of America

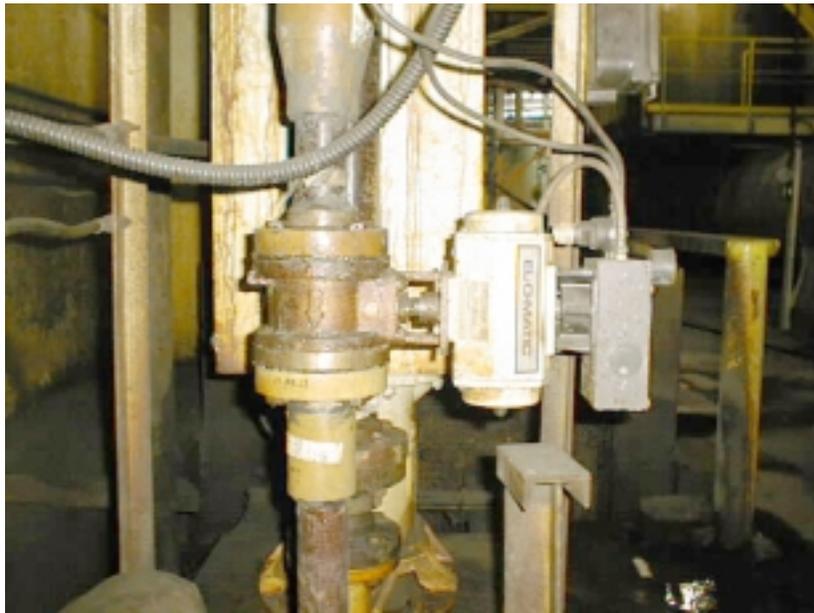
A standard 2" solid 99.5% alumina ceramic Cosmix ball valve with a C<sub>v</sub> 25 equal-percent characteristic trim, Hastelloy-C® stem, and Viton® O-Rings was shipped ex-local stock and installed in May 1998. The valve assembly carried a 24-month comprehensive warranty that covered corrosion, abrasion, and/or faulty workmanship.

Three months after installation, a modification to the pump to increase the flow in the line required a valve with a higher capacity. As all replacement parts in the Cosmix valve are fully interchangeable, a new larger capacity trim ball with a C<sub>v</sub> 50 was shipped via next-day courier to allow the valve to accommodate this increased flow requirement. The line needed to be isolated for less than half an hour while this retrofit was performed and the valve inspected.

To date, the valve is still in service - having provided an increased level of control accuracy for over 21 months. No corrosion or stem wear was visible three months after installation, when the valve was dismantled and retrofitted with a new ball.
