Ceramic ball valve controls erosive slurry without obvious wear

New Solutions to Plant Problems

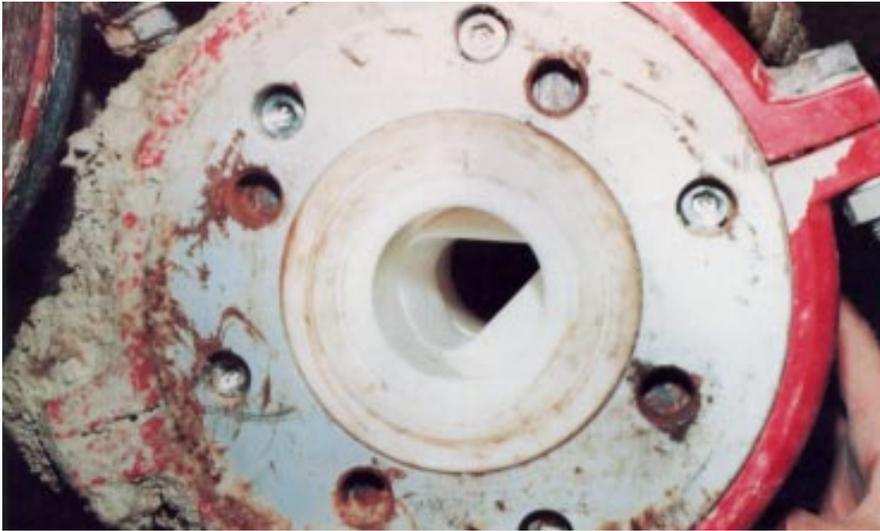
Ceramic ball and body of rotary control valve are still in like-new condition after months of service with extremely erosive slurry

control valve specially designed for extremely corrosive, abrasive and erosive service was installed in the slurry line. All critical wetted parts of the valve are cast alumina ceramic (Al_2O_3), a material next to diamond in hardness and almost impervious to wear, and resistant to strong acids and alkalis. Shaft materials include ceramic, stainless steel, Hastelloy® alloy, alloy 20 and titanium. The ceramic ball, body and end sections, which include tapped holes for pipe flanges, are completely encased in a steel housing for maximum strength and protection. The valve was awarded Top Honors for control valves in the 1984 CHEMICAL PROCESSING Vaaler competition.

Results: The 2" ceramic rotary control valve and pneumatic actuator have been trouble-free since they were installed in September, 1983. The award-winning valve has been inspected every six weeks and is still without visible signs of wear by the erosive slurry. The cost of the valve was repaid within the first year, and the indefinite projected service life will provide additional savings.
